Manhole Inspection Summary

Manhole # S35WW_010MH

Insp Date: **1/8/07 11:11 AM**

Location Address: **3046 GUILFORD AVE**

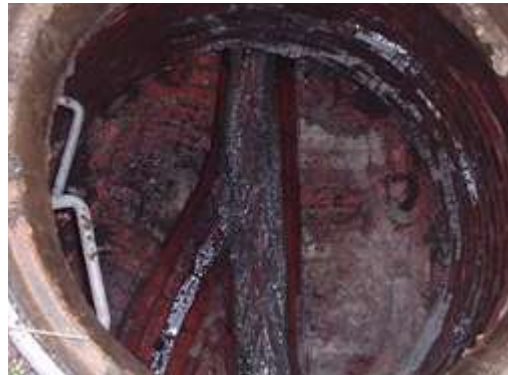
Top View

Evidence of surcharge - Bench debris.

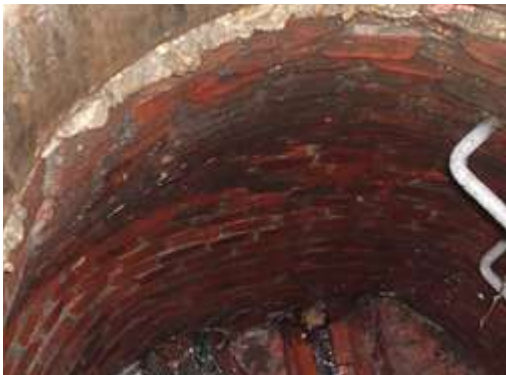
Defect

Frame leaks. Adjustment deterioration and infiltration. Corbel infiltration - other side.

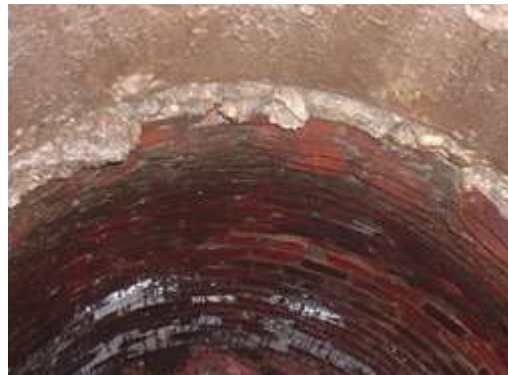
Defect

Frame leaks. Adjustment deterioration and infiltration. Corbel infiltration.

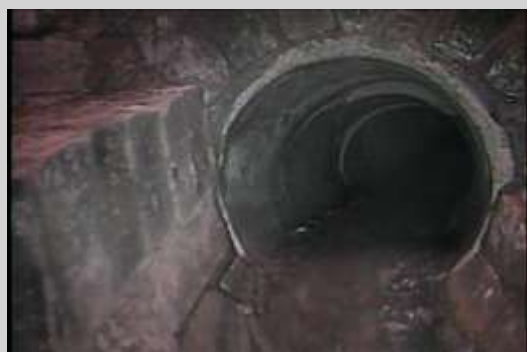
Pipe In @ 6 O'Clock

Infiltration: **Evidence** Pipe Seal Cond: **Unknown**

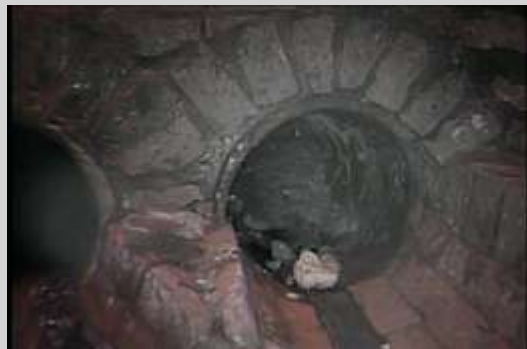
Pipe In @ 7 O'Clock

Infiltration: **Evidence**

Connects To: **Stub connection / abandoned**
